# Manhole Inspection Summary

Manhole # S35I\_\_022MH

Insp Date: **8/12/08 1:19 PM**

**Location** Address: **light st**

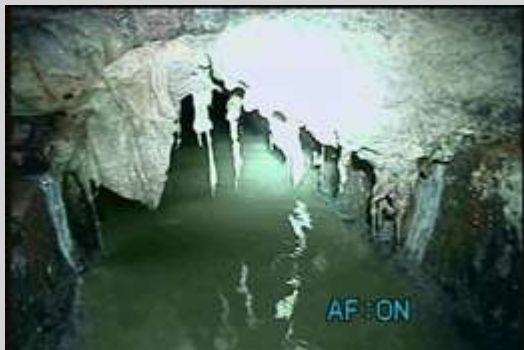
12 O'Clock Outflow

18 in. Circular Gravity Sewer  
Pipe Out @ 12 O'Clock

Pipe Material: **Clay** ☐ Pipe Lined

Invert Depth: **14.16** (ft.) Flow Characteristics: **Fast**

Deposits: ☒ None ☐ Mud ☐ Sludge ☐ Debris ☐ Grease

Infiltration: **None** Pipe Seal Cond: **Unknown**

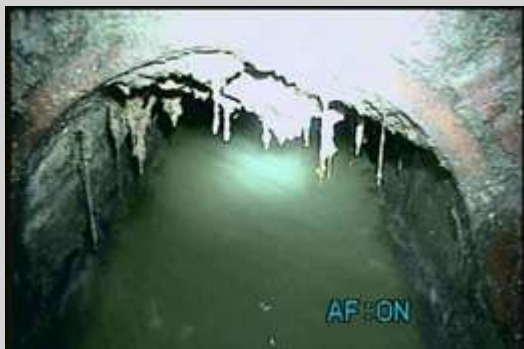
5 O'Clock Inflow

18 in. Circular Gravity Sewer  
Pipe In @ 5 O'Clock

Pipe Material: **Clay** ☐ Pipe Lined

Infiltration: **None** Pipe Seal Cond: **Unknown**
